**Flood Control Project Maintenance
Levee Inspections**

Maintenance Issue Types Only, Levee Inspection Report By Mile - Spring 2017

Reclamation District No. 2063 Crows Landing

Waterway	Bank	Unit Miles	Inspection Start/End	Inspector
Unit No. 01 San Joaquin River	Right	10.44	04/11/2017 04/11/2017	Richard Willoughby

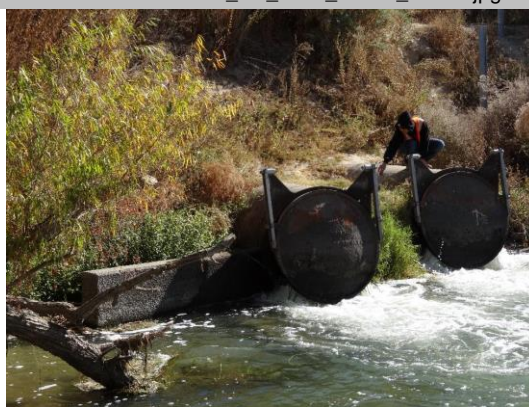
Photo 2 of 3 : UCIP_SP_2017_50218_43203.jpg

WS view: two outfall CMP pipes with flap gates on concrete headwall.

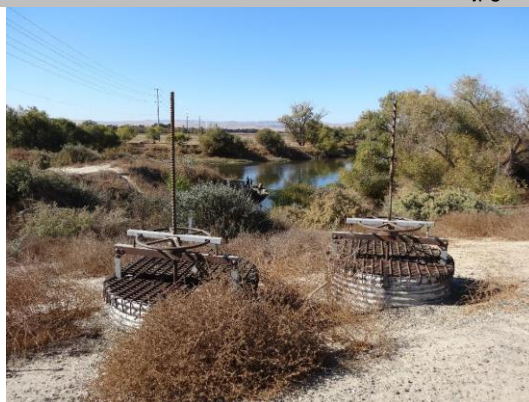
Photo 1 of 3 : UCIP_SP_2017_50217_43217.jpg

Comment Code					
Inspector Comment					
FS_ID:50217					
DS_ID:22119					
EP_NO: N/A					
Repair Type: No Action Needed					
Crossing Status: Found					
UCIP Comments: 08/23/2016: WS flapgates were held open by a piece of wood. Pipes may be used temporarily for irrigation. (K. Fazel - UCIP)11/05/2013: working during field inspection. (P. Amatya - DWR)					
FIELD_STRUCT_DESC: 2 of 2: Gravity drain structure. Two 48-inch CM pipes through the levee 25.5 feet below the crown. Slide gates in CM pipe risers on the waterward slope. Flap gates on the waterward ends. Cobble spillway 70 feet in length to river. (Lateral Drain No. 5) installed by USCE 1961. O&M Manual SJR 006, Sept. 1961.					
FS Date: 11/5/2013

WS view: two CMP risers with slide gates on levee slope.

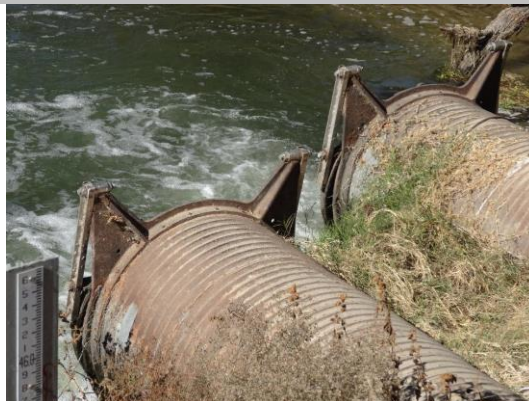
Photo 2 of 3 : UCIP_SP_2017_50217_43216.jpg

WS view: two CMP outfall pipes with flap gates on levee slope.

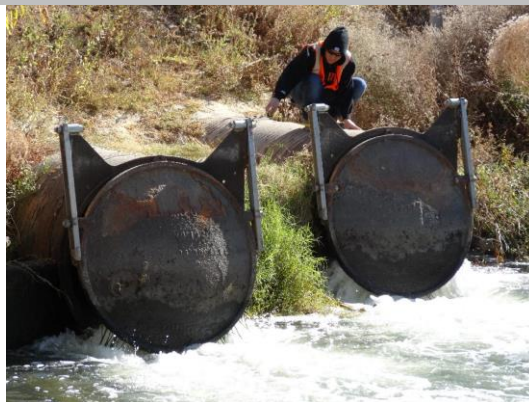
Photo 3 of 3 : UCIP_SP_2017_50217_43215.jpg

WS view: front view of two CMP outfall pipes with flap gates on levee slope.

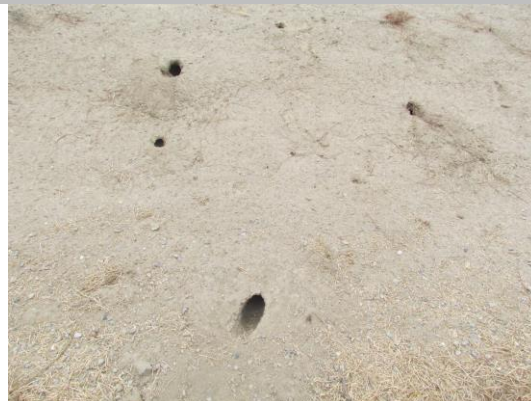
Photo 1 of 2 : SP_2017_RD2063_112_11_20170411_00004.jpg

LM Start	1.71	Rating **	A/W	Issue No.	11
LM End	1.74	Issue Type +	Ma	Location *	LS
Category	Earthen Levee			GPS Latitude/Longitude	
				Start	End
Item	Animal Control			37.459209 °	37.458964 °
				-121.033126 °	-121.033420 °
DWR ID	DWR_RD2063_01_s_2012_11				
Comment Code					
A3 : No rodents visible, but rodent burrows visible; need to backfill and compact or grout burrows.					
Inspector Comment					
Several rodent holes noted on landward slope.

Looking at several rodent holes on landward slope.

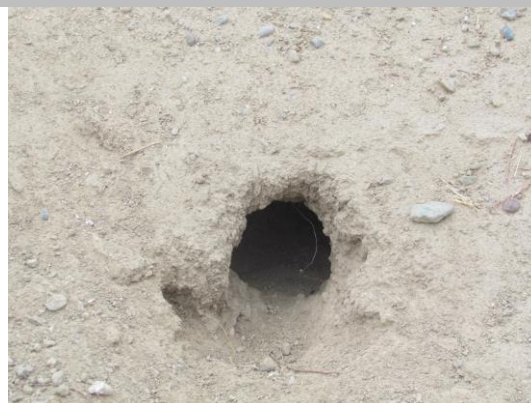
Photo 2 of 2 : SP_2017_RD2063_112_11_20170411_00005.jpg

Looking at close-up view of rodent hole on landward slope.

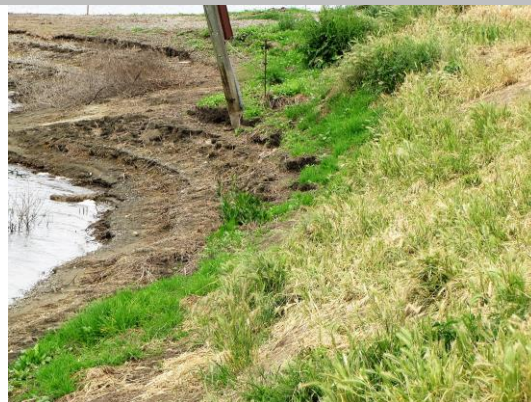
Photo 1 of 2 : SP_2017_RD2063_112_59_20170411_00121.jpg

LM Start	1.83	Rating **	M	Issue No.	59
LM End	1.93	Issue Type +	Ma	Location *	WS
Category	Earthen Levee			GPS Latitude/Longitude	
				Start	End
Item	Erosion / Bank Caving			37.457653 °	37.456258 °
				-121.033728 °	-121.033645 °
DWR ID	DWR_RD2063_01_s_2017_59				
Comment Code					
E1 : Note and monitor erosion site.					
Inspector Comment					
Minor erosion at waterward toe.

Looking downstream at minor erosion on waterward slope.

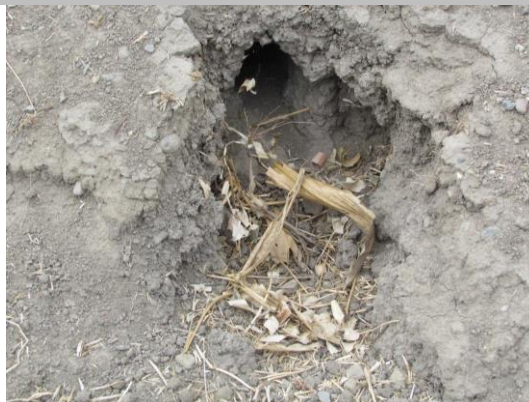
Photo 1 of 2 : SP_2017_RD2063_112_46_20170411_00013.jpg

Looking at close-up view of rodent hole with corn husk at the entrance of the hole.

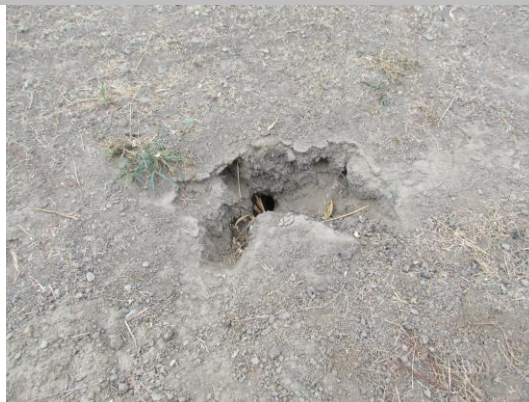
Photo 2 of 2 : SP_2017_RD2063_112_46_20170411_00014.jpg

Looking at large rodent hole on landward slope.

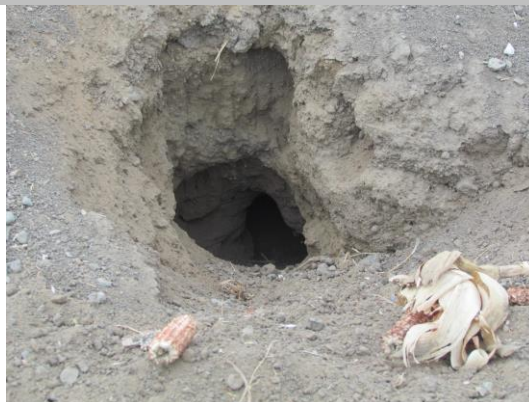
Photo 1 of 3 : SP_2017_RD2063_112_47_20170411_00015.jpg

LM Start	2.34	Rating **	A/W	Issue No.	47
LM End	2.37	Issue Type +	Ma	Location *	LS
Category	Earthen Levee			GPS Latitude/Longitude	
				Start	End
Item	Animal Control			37.451394 °	37.451064 °
				-121.029426 °	-121.029072 °
DWR ID	DWR_RD2063_01_f_2016_47				
Comment Code					
A3 : No rodents visible, but rodent burrows visible; need to backfill and compact or grout burrows.					
Inspector Comment					
Large rodent holes on landward slope.

Looking at close-up view of rodent hole with corn and corn husk at the entrance of hole.

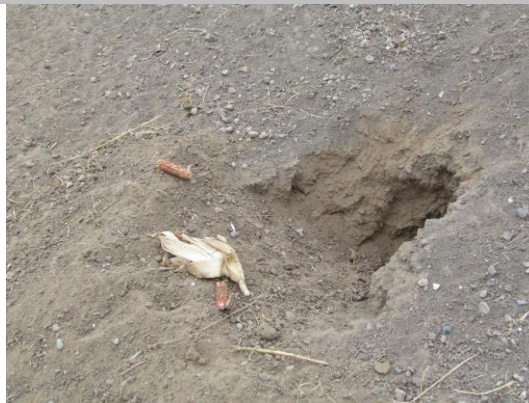
Photo 2 of 3 : SP_2017_RD2063_112_47_20170411_00016.jpg

Looking northwest at rodent hole on landward slope.

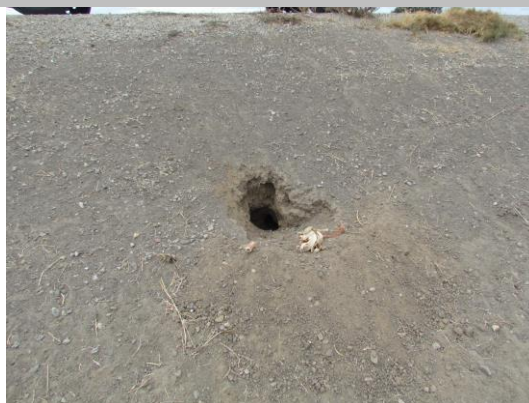
Photo 3 of 3 : SP_2017_RD2063_112_47_20170411_00017.jpg

Looking west at rodent hole on landward slope.

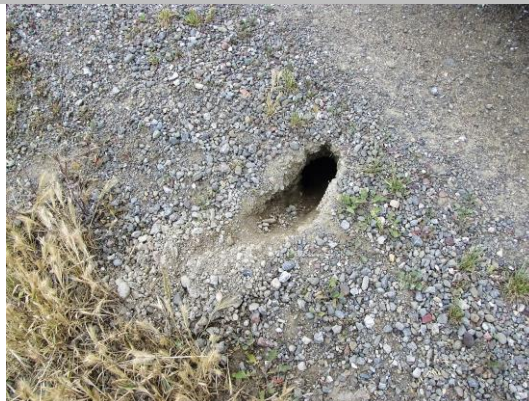
Photo 1 of 1 : SP_2017_RD2063_112_60_20170411_00123.jpg

Looking at typical rodent hole on landward shoulder.

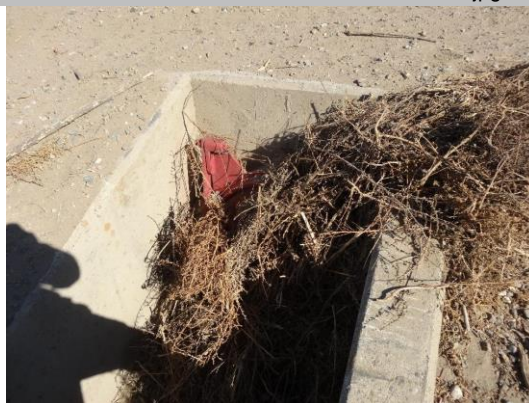
Photo 2 of 3 : UCIP_SP_2017_24443_43521.jpg

WS view: pipe, flap gate, and concrete headwall with debris blocking the outlet.

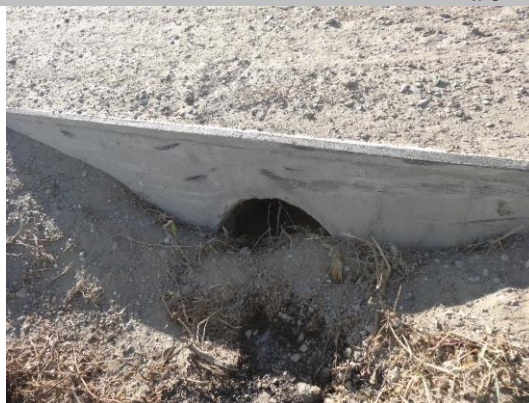
Photo 3 of 3 : UCIP_SP_2017_24443_43520.jpg

WS view: pipe, flap concrete headwall with soil debris blocking the inlet.

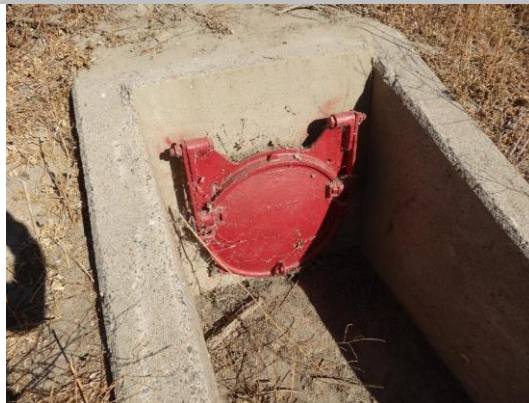
Photo 2 of 3 : UCIP_SP_2017_24469_43644.jpg

FS_ID:24469
DS_ID:22089
EP_NO: N/A
Repair Type: Non-Urgent
Crossing Status: Found
UCIP Comments: - cleaning required in inlet pipe.- new flap gate
FIELD_STRUCT_DESC: 24-inch CM pipe through the levee 12.5 feet below the crown. Flap gate on the waterward end. Concrete headwall on both ends. O&M Manual SJR 006, Sept. 1961.
FS Date: 11/5/2013

WS view: new flap gate, and U typed concrete headwall.

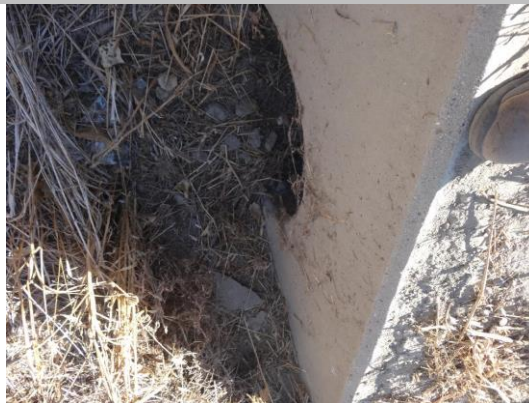
Photo 3 of 3 : UCIP_SP_2017_24469_43643.jpg

LS view: CM pipe and concrete headwall on levee slope. Debris blocking inlet pipe.

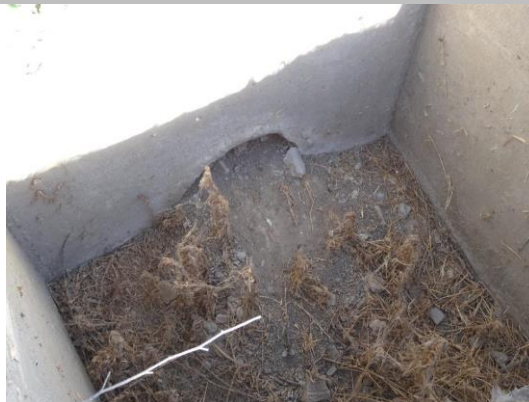
Photo 3 of 3 : UCIP_SP_2017_24485_43665.jpg

LS view: inside view of inlet box on levee toe. Debris blocking inlet pipe.

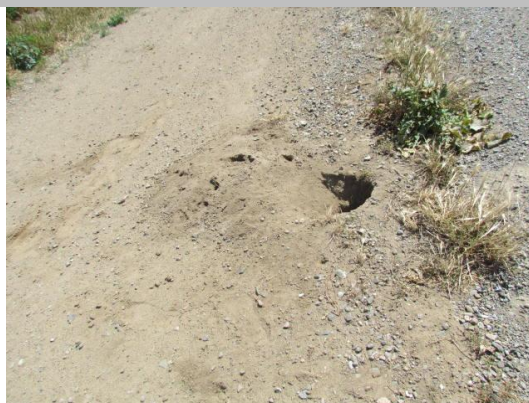
Photo 2 of 2 : SP_2017_RD2063_112_29_20170411_00010.jpg

Looking south at typical rodent hole on landward shoulder.

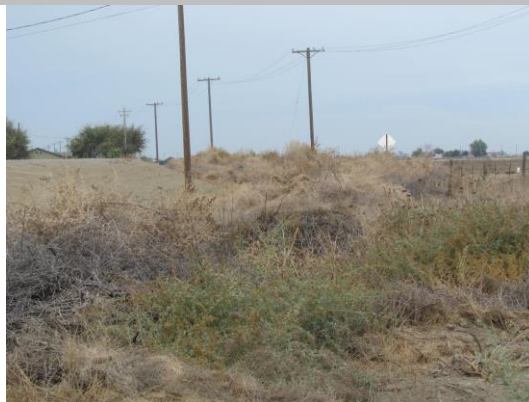
Photo 1 of 2 : SP_2017_RD2063_112_2_20170411_00001.jpg

Looking north at dense veg at landward toe and berm.

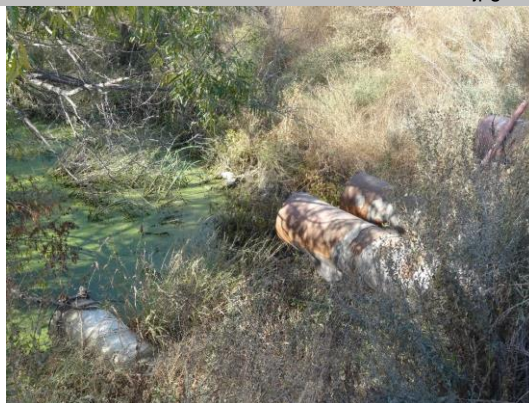
Photo 2 of 3 : UCIP_SP_2017_25026_45114.jpg

WS view: discharge pipes end on levee toe. No flap gates on right 3 pipes.

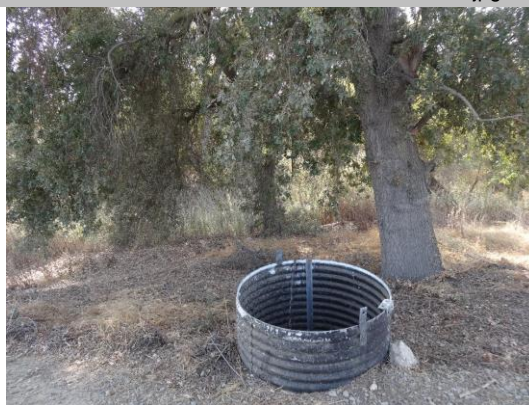
Photo 1 of 3 : UCIP_SP_2017_25031_45141.jpg

WS view: CMP riser with slide gate. Missing slide gate handwheel.

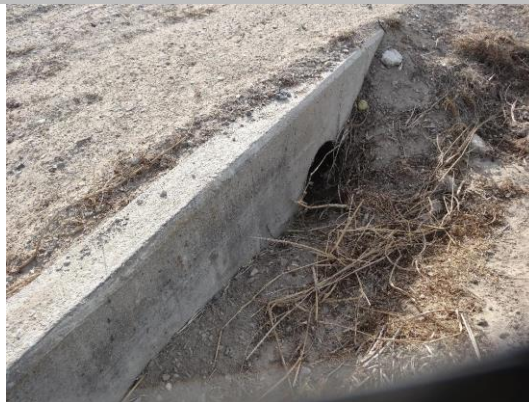
Photo 2 of 2 : UCIP_SP_2017_24645_43987.jpg

LS view: concrete headwall and partially blocked inlet opening.
